Hoffer Brook Restoration Project

December 2014

Report prepared by: Ruth Hawksley, Wildlife Trust BCN

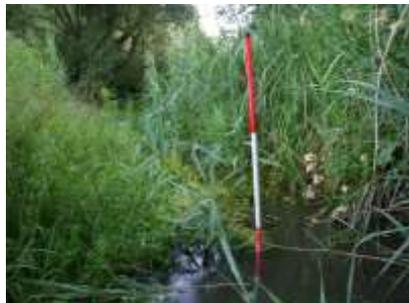
The bed at the upstream end was soft, deep silt, which gravel was likely to sink into. However, it was a key area for bed-raising due to a deep hole immediately downstream of the railway bridge. The soft silt continued for approximately half the length of the bed raising.

Before work started

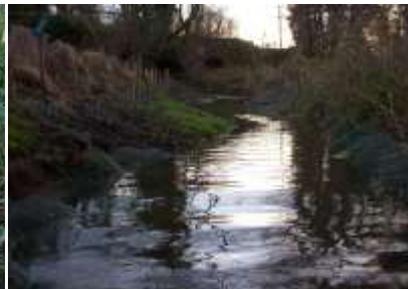
During gravel placement a hole developed in the mesh, probably at a join, and although the bed looked solid it was possible to sink into the hole. A week later, the gravel had locked together and there was no sign of the hole at all; the whole bed was firm.

After de-silt and mesh placement

This challenge was addressed by laying plastic mesh over the silt and adding the gravel on top. The plastic mesh was joined in sections with cable ties and secured to the banks with posts and rope. Gravel placement raised the original bed level by approximately half a metre. Woody debris was also used, and fixed in place under gravel.

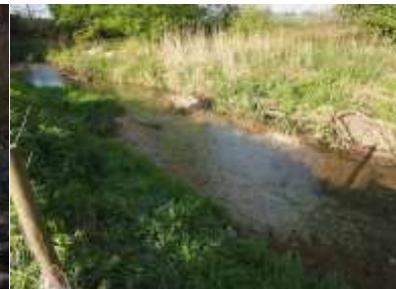
With gravel and woody debris

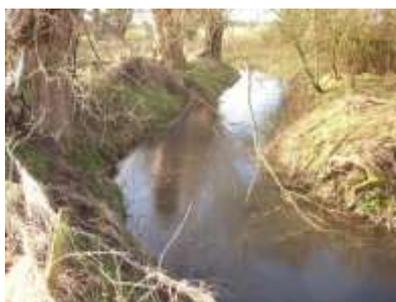
Before

Channel narrowing was also carried out at Area 1, with posts and faggot bundles, backfilled with brush, then with soil and silt from the work area.

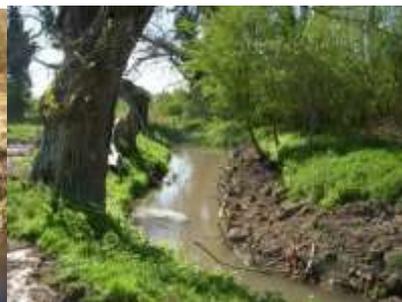
Faggot narrowing backfilled

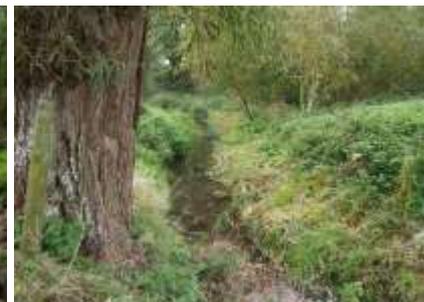
5 months later

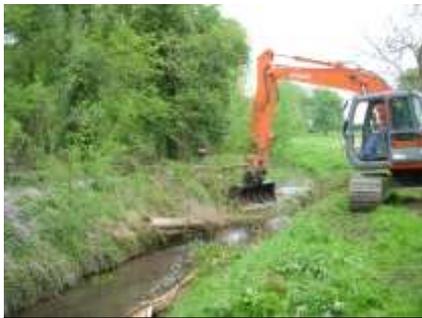
Woody debris added to channel

On this stretch, a machine was used to re-profile the bank and to add gravel to create a point bar on the meander. This created a pinch point which speeds up the water on the outside of the bend and provides a better variety of bank conditions for marginal plants. Woody debris from fallen trees was repositioned into the channel to protect the banks and increase flow diversity.

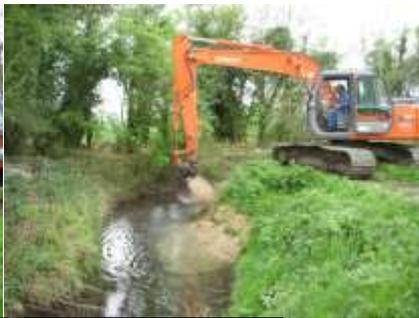
Addition of gravel

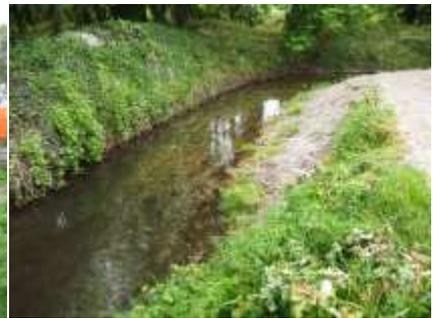
Re-shaped point bar

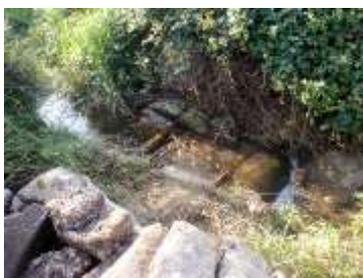
An old culvert carrying the ditch under the brook had been replaced by two concrete pipes, then covered in cement sandbags and rocks. Even when the sandbags were removed, the concrete pipes impounded water and made fish passage difficult. Gravel was used to make the slope smoother, being raked by hand over the pipe to ensure there was no damage. This also created a good area for fish spawning and the riffle will improve oxygenation of the water. An old farm bridge crosses the brook just downstream of this point. The gravel did not continue under the bridge so that the deep water here would give it some protection from flooding.

Pipe with stones removed

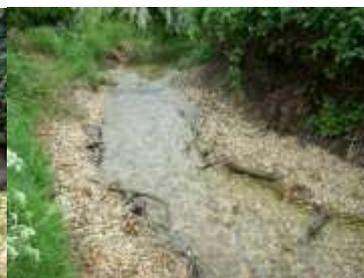
Completed gravel glide

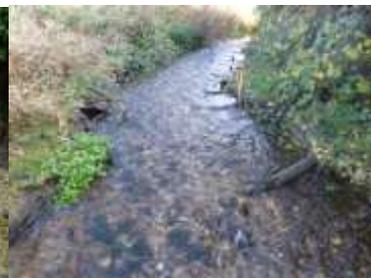
7 months later (December)

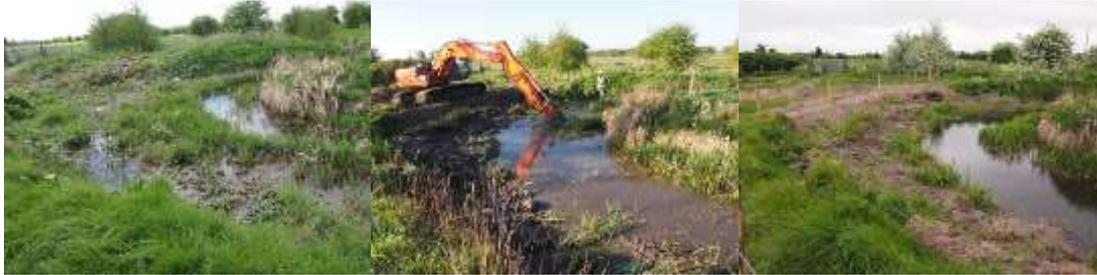
This section of brook was the main cattle drinking point. Severe poaching had lowered the bank so that water tended to flow across the field into the low-level ditch rather than along the brook. The low-level ditch flows under the main river and joins it downstream of a nearby mill. This two-level system needs to function for current use of the land to continue.

Before – showing poached marshy area and lower access point

Re-building in progress

Finished bank

The bank here was rebuilt using wood, soil and silt won locally and compressed by the machine to create a firm shape. The entire right (east) bank was then fenced to exclude cattle. Restricting cattle to dedicated drinks (in this case on the nearby main river as there was no suitable location on the brook) reduces erosion and reduces the amount of silt going into the watercourse.

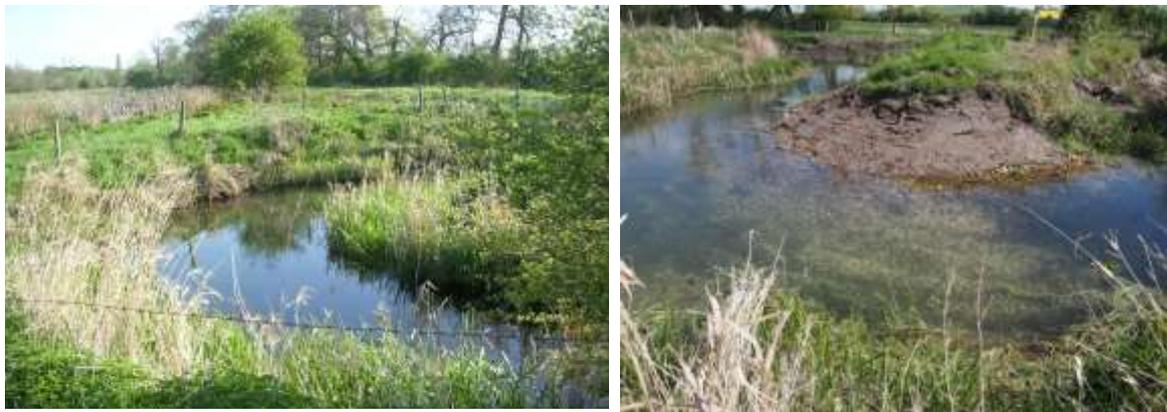
Before

After – with gravel and re-shaped bank

The bank was re-shaped on a tight bend to narrow the channel slightly and raise the bed with gravel.

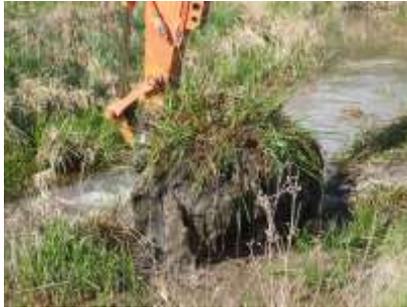
"Turf" cut from marginal vegetation

Vegetation management and de-silting were required by the landowner and drainage authority (South Cambridgeshire District Council). This was carried out in a sensitive way so as not to over-deepen the channel. "Turfs" of vegetation were used to stabilise and help repair poached banks.

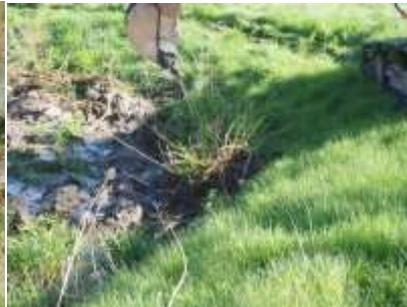
"Turf" placed at bank edge

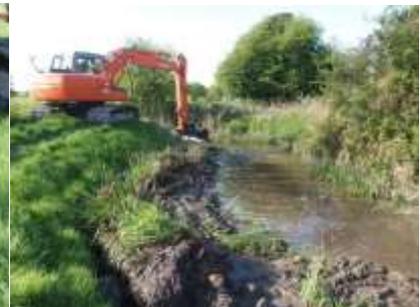
Section of re-profiled bank

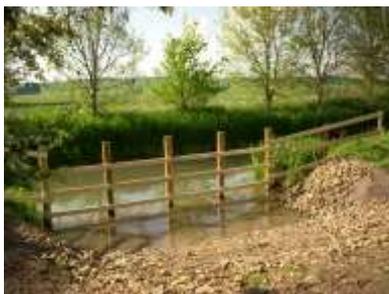
Example of improved cattle drink

The mesh seems to be working very well to support the gravel, and it is intended to monitor over a number of years with the intention of noting what happens when the mesh, posts and rope finally fail. All the pasture has been grazed since the project was completed and the cattle drinks are working, although they would perhaps have been improved by more gravel or a concrete hard standing.

Cattle drinking areas were created or improved as part of managed access to the water. Three fenced drinks were built and a pond enlarged.

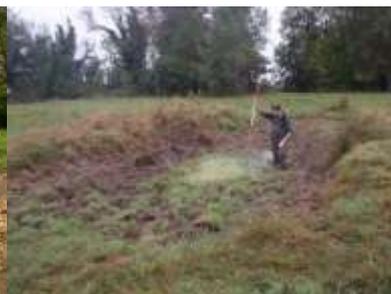
Pond before work

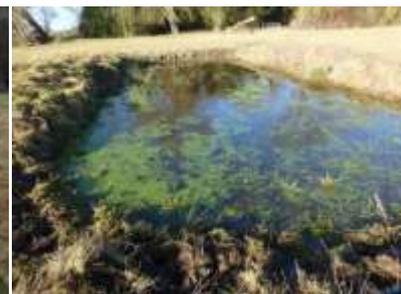
Pond after work
