Bourn Brook Water Vole and Invasive Plants Survey

Spring 2017

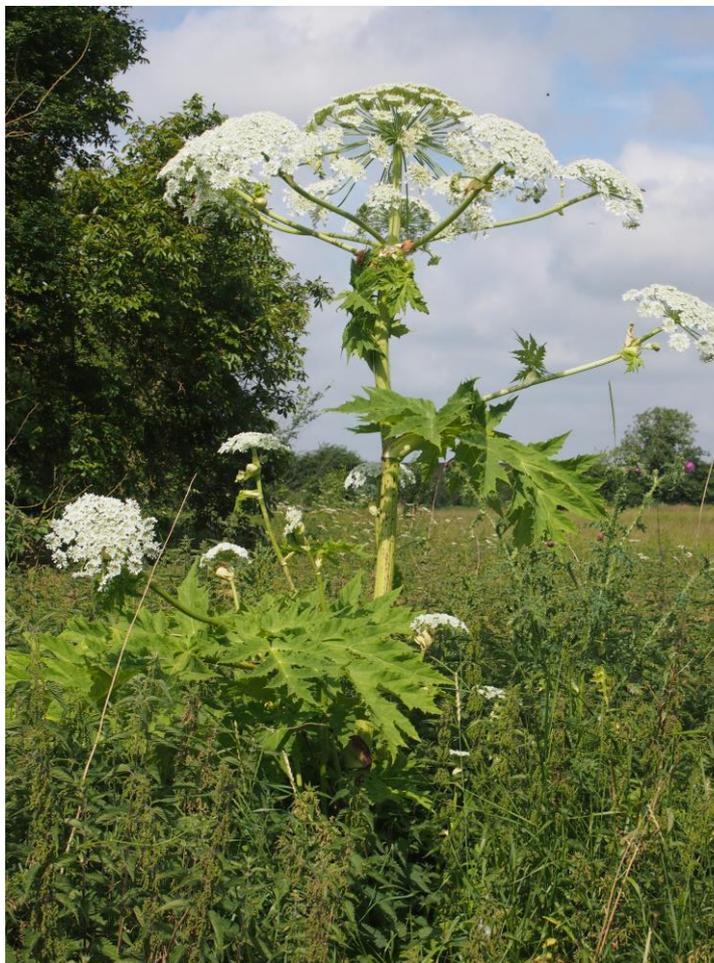
Giant hogweed
flowering on the
Bourn Brook,
2015

We will continue to treat the giant hogweed and to monitor it, with the aim of eradicating this plant from the brook.

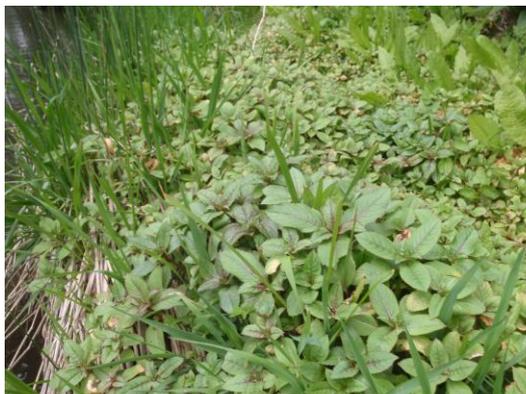
Young Himalayan balsam growing in a “huge” patch. Bourn Brook 2017.

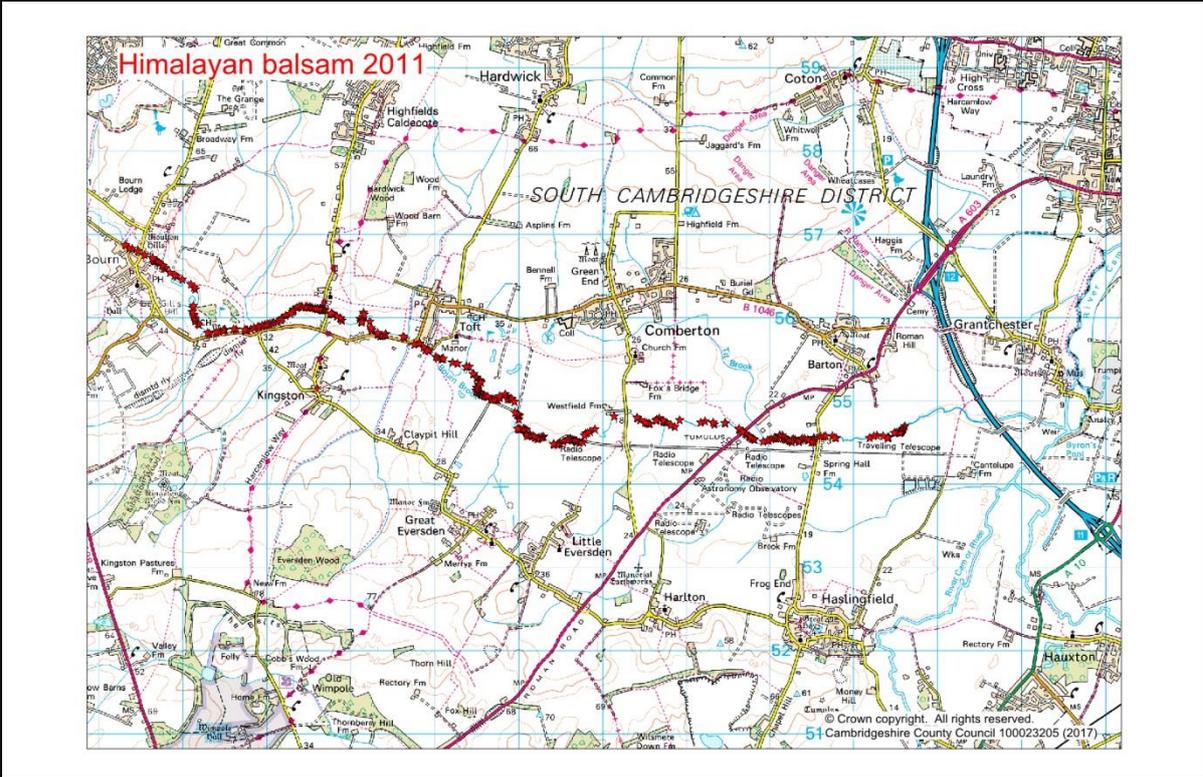
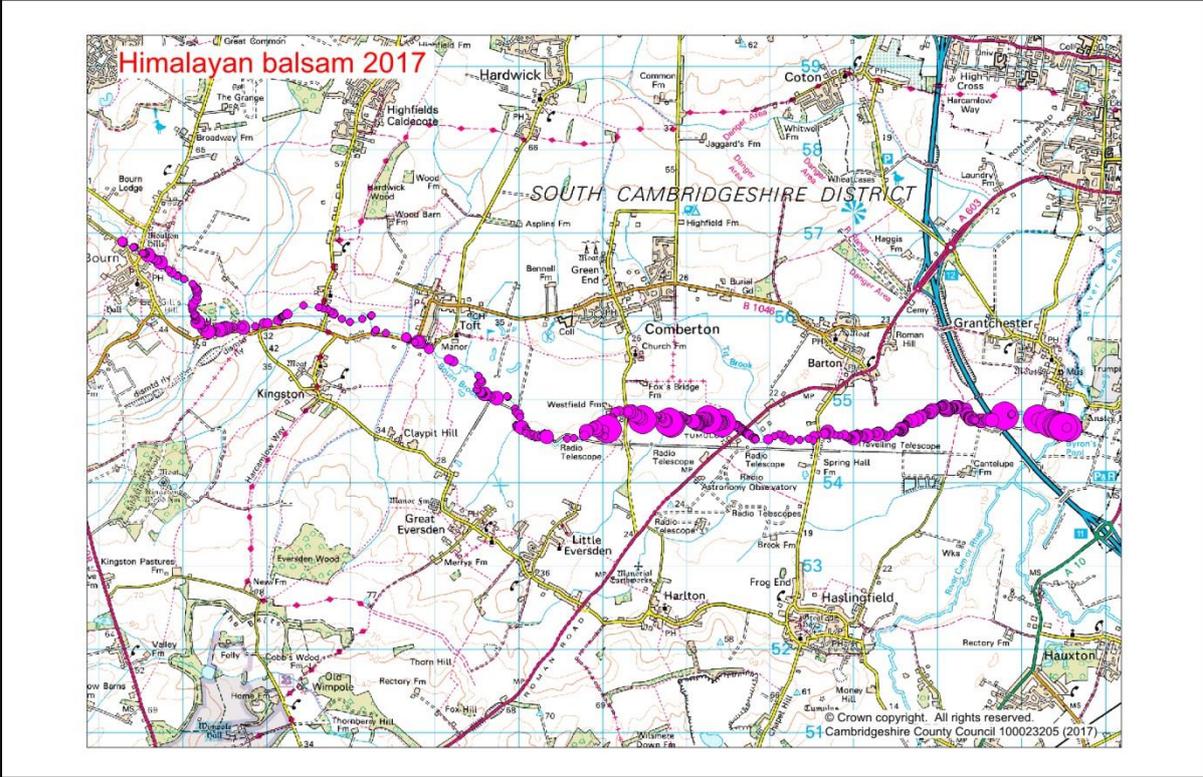
The maps below (from 2011 and 2017) are not directly comparable, but they do illustrate some key points:

- The “huge” patches of balsam are almost exclusively on sections where no control occurred in the last couple of years. The upper of these sections had a relatively small amount of balsam in 2011, but control efforts stopped here in order to focus on the upstream areas. The implication is that had no control occurred, much of the brook would now have considerably more balsam. The lower section was not surveyed in 2011 but has had no control work.
- The upper stretch, particularly the golf course at Bourn, was one of the worst affected sections in 2011. It is also one of the most tricky to work on. Although the maps don't make it obvious, the number of plants seems to be reduced even here.
- Obvious reductions in the amount of balsam have occurred downstream of the Bourn golf course.

Continue to control balsam and re-survey in 3 years' time to see whether there has been a measureable change. Continue to focus on the upstream section and recruit local people to report any plants that were missed.

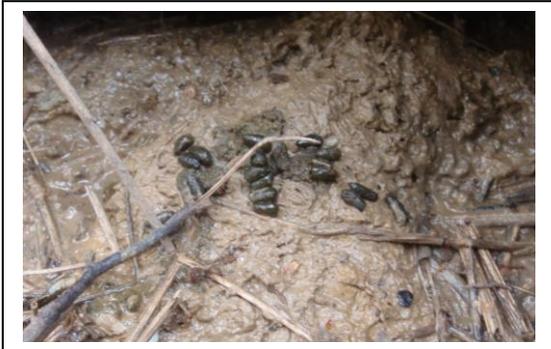
Latrines: areas where water voles mark their territory. Older droppings are stamped down and marked with scent before new droppings are left on top.

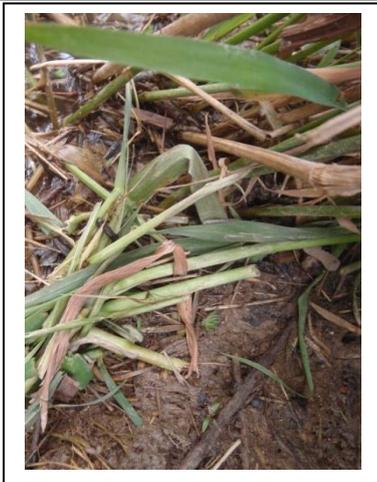
Feeding stations: areas where water voles drop chewed vegetation. This is often bitten off at a 45° angle and neatly stacked.
