Hoffer Brook Restoration Project

December 2014

Report prepared by: Ruth Hawksley, Wildlife Trust BCN

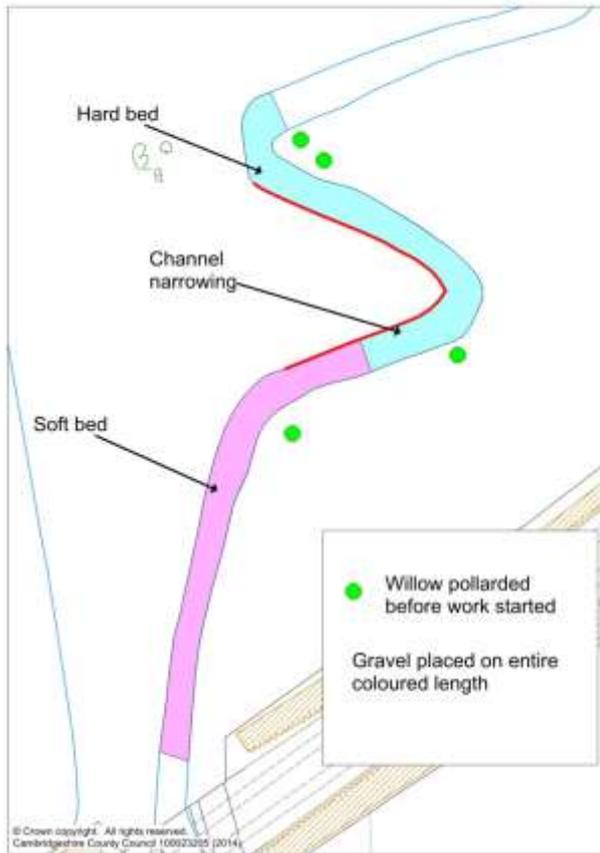
Area 1:

The bed at the upstream end was soft, deep silt, which gravel was likely to sink into. However, it was a key area for bed-raising due to a deep hole immediately downstream of the railway bridge. The soft silt continued for approximately half the length of the bed raising.

This challenge was addressed by laying plastic mesh over the silt and adding the gravel on top. The plastic mesh was joined in sections with cable ties and secured to the banks with posts and rope. Gravel placement raised the original bed level by approximately half a metre. Woody debris was also used, and fixed in place under gravel.

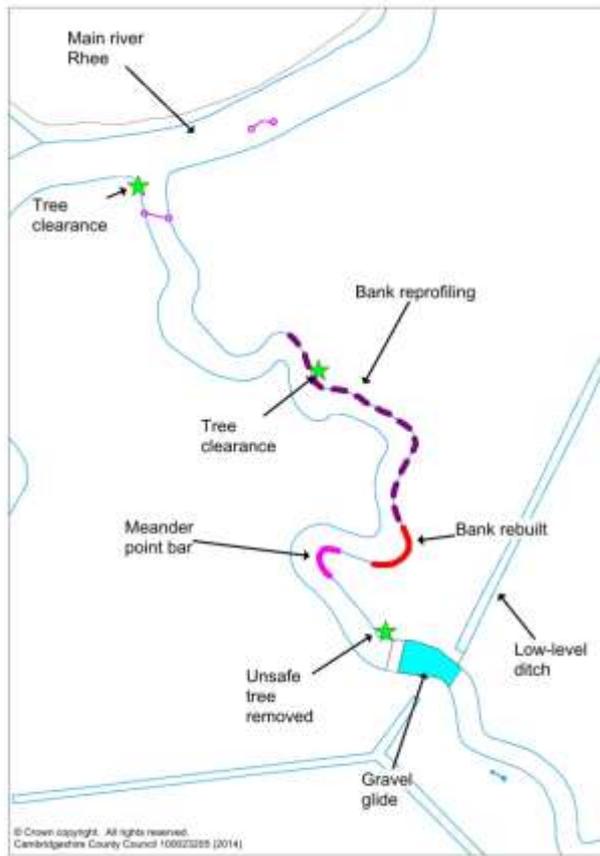
Area 3:

This lower reach was the most damaged by cattle poaching. The main tasks were:

An old culvert carrying the ditch under the brook had been replaced by two concrete pipes, then covered in cement sandbags and rocks. Even when the sandbags were removed, the concrete pipes impounded water and made fish passage difficult. Gravel was used to make the slope smoother, being raked by hand over the pipe to ensure there was no damage. This also created a good area for fish spawning and the riffle will improve oxygenation of the water. An old farm bridge crosses the brook just downstream of this point. The gravel did not continue under the bridge so that the deep water here would give it some protection from flooding.

- To create a smooth gravel glide over the pipe carrying the low level ditch under the brook;
- To build up a severely poached section of bank, which was allowing water to overflow from the brook into the low-level ditch;
- To create a meander point bar;
- To re-profile banks using cut “turfs”;
- To fence the entire length to keep cattle out;
- Tree work to remove a dangerous tree, to clear sections of channel which are impeding drainage and to lift the canopy. Some of the wood was used to strengthen the bank.
